# FACILITY COMPLIANCE INSPECTION REPORT

## Division of Waste Management Solid Waste Section

Graham County Municipal Solid Waste Landfill  
 Atoah Road  
 Robbinsville, N. C. 28771

Comprehensive Audit of Closed MSW Landfill

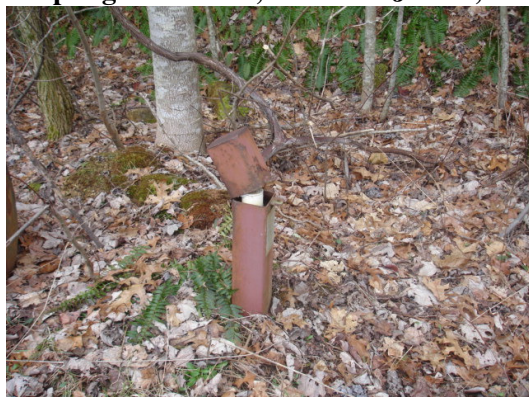
1. All photographs were taken by Troy Harrison on February 21, 2012.
2. The Landfill ceased operations on April 8, 1994. The property that the landfill is located on is owned by the US Forest Service.
3. The entrance to the landfill was secured by a locked gate.
3. **The three groundwater monitoring wells were observed. None of the wells were secured. 15A NCAC 02C .0108 (k) requires that “all non-water supply wells, including temporary wells, shall be secured with a locking well cap to ensure against unauthorized access and use.” The security of the wells was also mentioned in the March 17, 2009 audit. As a reminder, the results of the most recent groundwater sampling are due on, or before June 1, 2012.**

Unsecured Monitoring Well No. 2

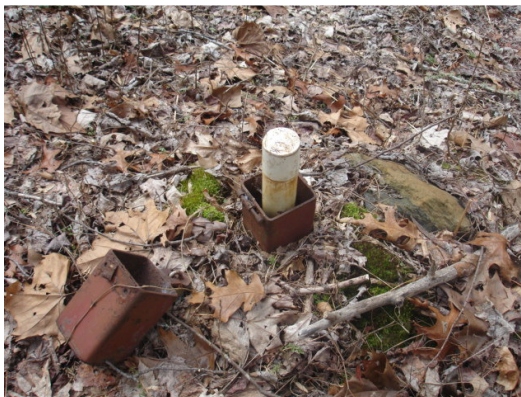
Unsecured Monitoring Well No. 1

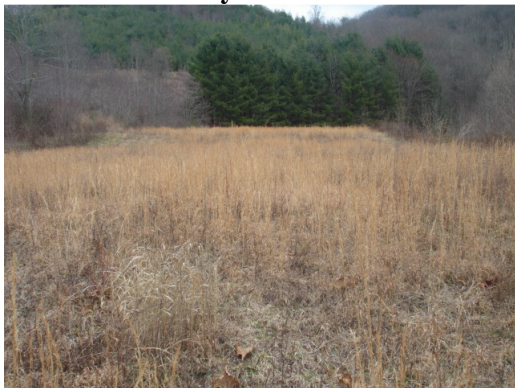
4. The cap of the landfill had not been mowed in quite some time and briars were starting to appear. In addition, it is unclear where waste was deposited at the landfill. There were also trees in areas that could be growing over waste. Graham County needs to clearly locate and permanently mark the edge of waste boundary.

Top of landfill

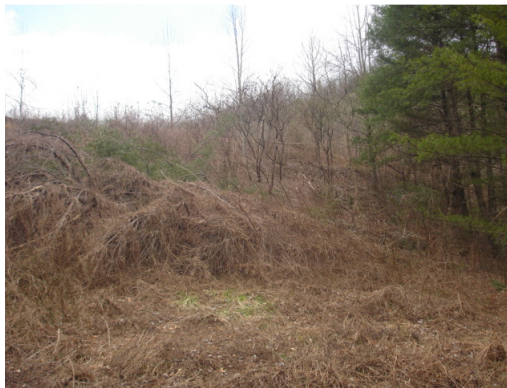
possible woody vegetation over waste
